# Evaluation of an Artificial Rock Reef for Colonization by Macroalgae

## Abstract

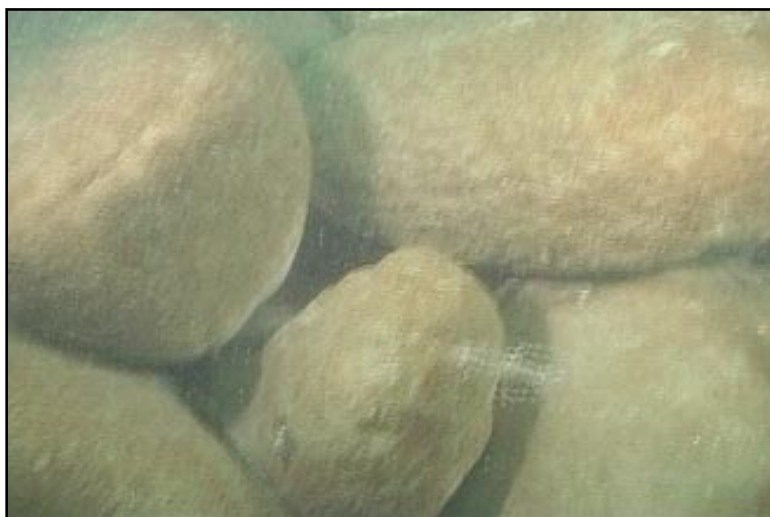
**Figure 1.** April 3, 2001- Rock deposited at site February 8, by April diatoms are present.

The rock finger was deposited on soft sediment on February 8, 2001. Two months later, April 3, 2001 the rock finger had a layer of diatoms but no other visible algae (Figure 1). Almost 7 months after the bare rock was deposited, August 30, 2001, there was 70% of the rock covered by species of red, green and brown algae (Figure 2). The largest area was covered by *Laminaria groenlandica* (Figure 2). During sampling the next summer, May 2002, the percent algal cover had increased to 99.1%. Keep in mind these are just surface measurements and no account was attempted of the multiple layers of kelp (Figure 3). By September 13, 2002 we recorded the first decrease in percent cover with more bare rock showing and an increase in green and red algae, the percent cover was 77% (Figure 4). The record in year two of five shows a dramatic colonization of the bare rock reef and the first signs of decline (Figure 5).

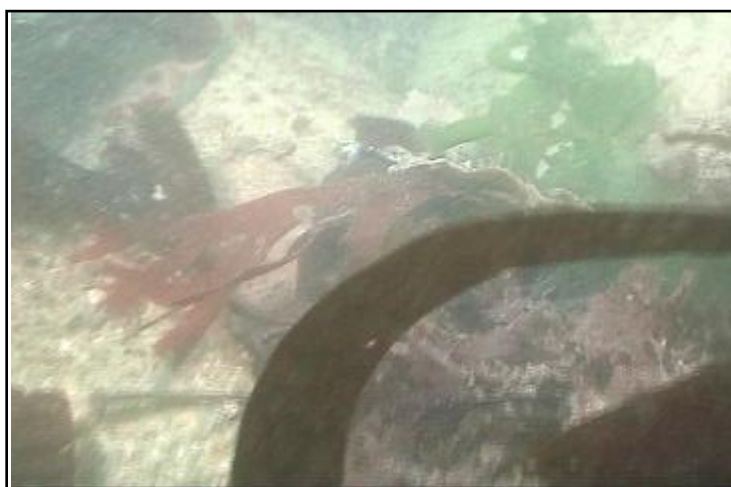
**Figure 2.** August 30, 2001 –Colonization has begun with 70% cover after 6 months.
